### **King (1489)**

**King Springs**, in southwest Christian County [N36°-44'-41"; W87°-36'-52.5"] is a three-spring perennial distributary draining to Little River. These springs, plus an additional overflow spring, are located along a 120 m (400 ft)-long Little River flood channel that is separated from the river by a narrow island. The distributary discharges from the top of the St. Louis Limestone (Klemic, 1966) at about 133 m (435 ft) elevation. A bluehole karst window is located about 90 m (300 ft) S of the main spring, which seasonally maintains a significant flow through a 5 m (15 ft) deep channel. This channel ends at a swallet about 25 m (75 ft) south of the main spring. During low flow the bluehole ceases discharge and becomes stagnant. None of the springs are mapped on the Herndon 7.5-minute Topographic Quadrangle nor the corresponding geologic map. They were inventoried during the early phase of this study.

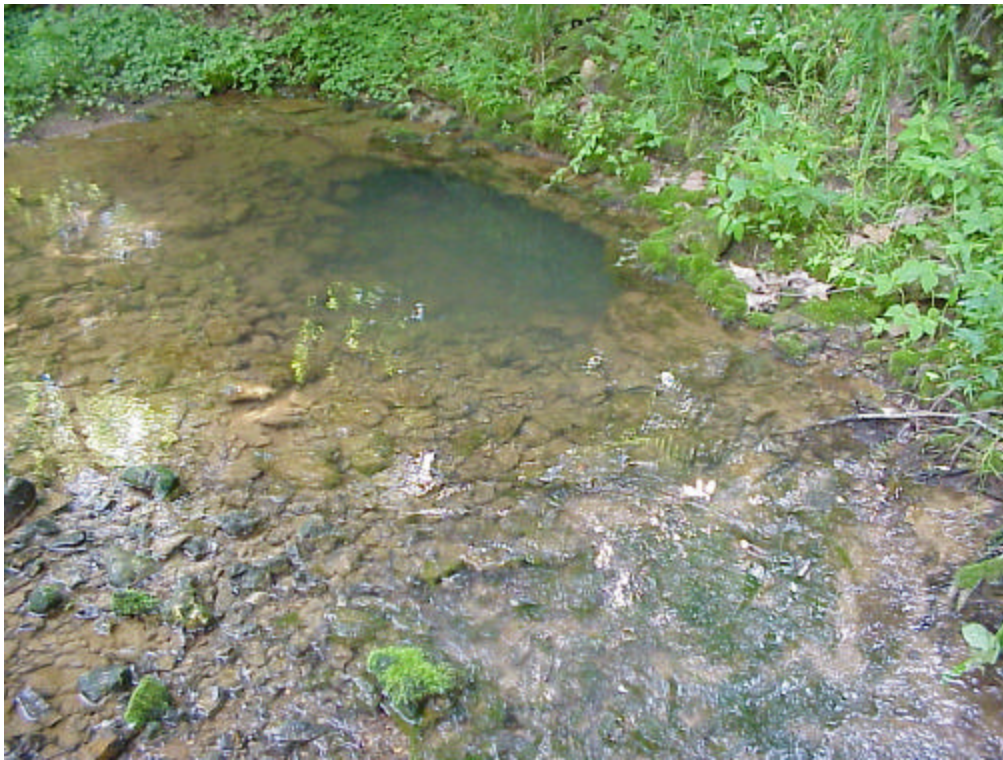
**Figure 11a: King Spring (Major)**

The combined low-flow discharge of King Springs was 60 L/s (2.1 ft<sup>3</sup>/s) on 11-19-97. The main downstream discharge point is a bluehole spring adjacent to a steep bank, which splits into two channels from a 1.5 m-wide (5 ft) rise pool. This main bluehole contributes about 50% of the total volume (Figure 11a). This spring (and an overflow spring) drains from the southwest end of the flood channel while two additional perennial springs, which appear to be free-draining gravity springs, join the river from the north end of the flood channel. The spring furthest upstream contributes about 37% of the total while the third spring adds the remaining 13%. See Figure 11b for a map of the drainage basin.

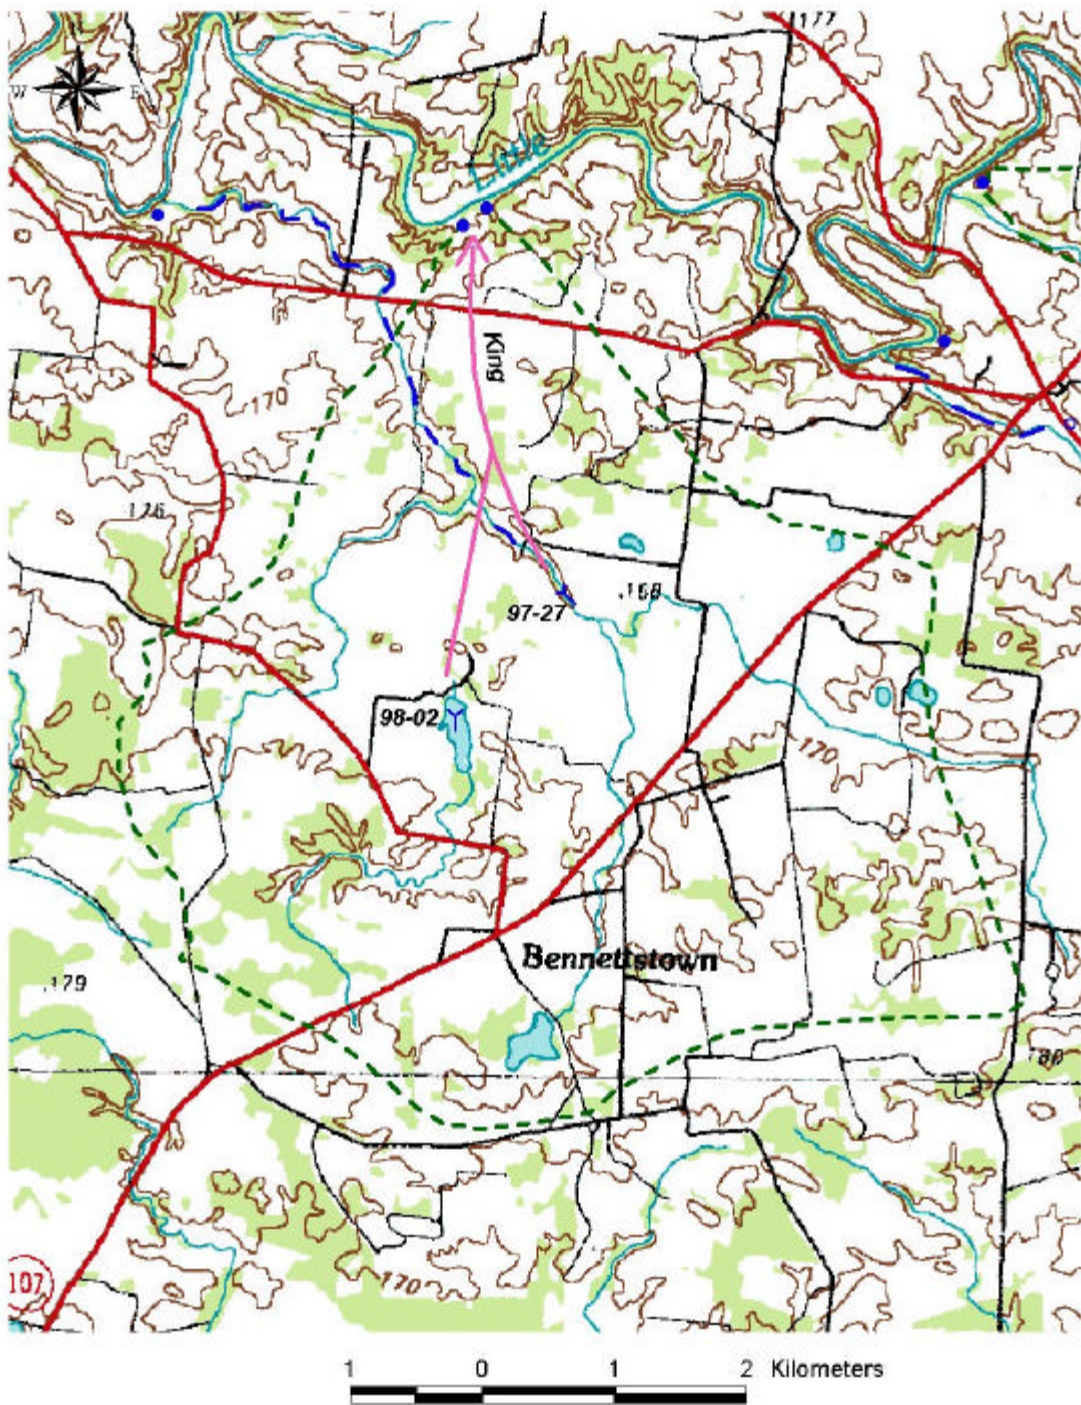
**Figure 11b: King Springs Basin:**

Low-Flow Discharge 59.5 L/s (2.1 ft<sup>3</sup>/s); Basin Area 28.2 km<sup>2</sup> (10.9 mi<sup>2</sup>); UBF 2.1 L/s/km<sup>2</sup> (0.19 ft<sup>3</sup>/s/mi<sup>2</sup>); Land use 85.2% Agricultural, 7.4% Forest (4.1% Woody Wetlands)

*December 4, 1997:* 250 g (9 oz) of fluorescein was injected into **Thomas Pools**, where a losing stream was infiltrating a gravel channel. Eight days later, three perennial springs within the King Springs distributary, 3 km (2 mi) to the north, were extremely positive (+++) and two overflow springs were positive (+), while nearby McGraw Spring was negative.

*January 13, 1998:* 250 g (9 oz) of Direct Yellow 96 was injected at **Smithson Insurgence**. Nine days later, King Spring (downstream), 3.5 km (2.25 mi) to the north, was positive on a cotton dye receptor, while King Spring (upstream) was inconclusive. On *April 9, 1998*, this injection was replicated, with 30 g (1 oz) of fluorescein, in order to confirm the distributary indicated from trace # 97-27. The dye receptor pickup 36 days later indicated that both King Spring, upstream (+) and downstream (+), were positive.

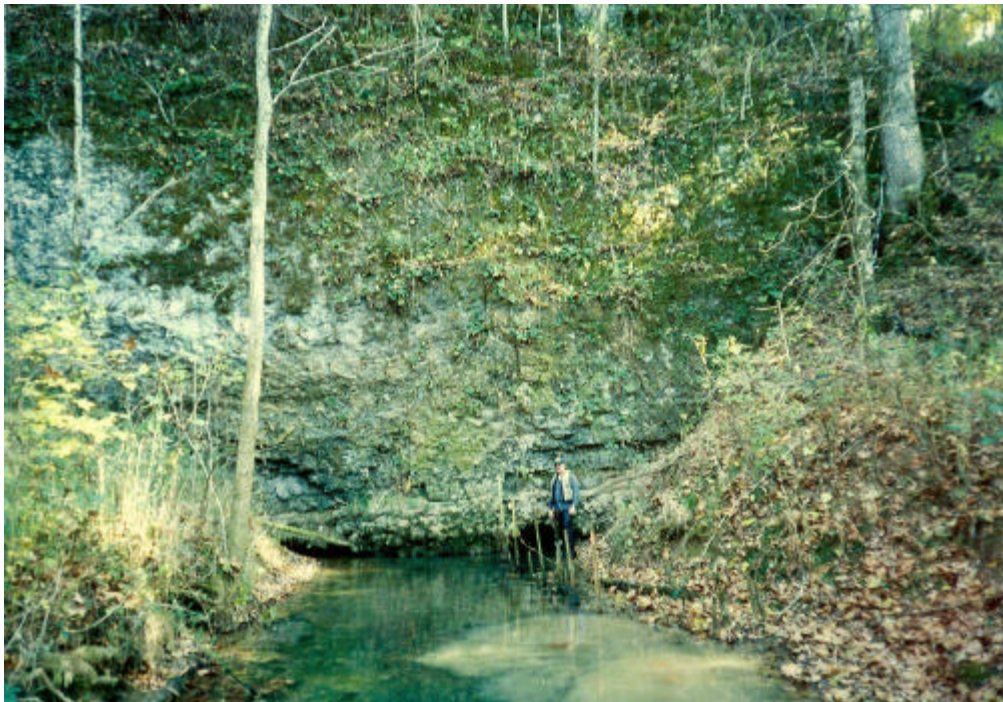
**Figure 12a: Brelsford Spring**

**Brelsford Spring** (Figures 12a & 12b) in east-central Trigg County [N36°-49'-19"; W87°-46'-35"] is a free draining gravity spring that flows from the base of a 12 m (40 ft)-high limestone bluff and forms a 120 m (400 ft) spring run to the south side of Little River.

Brelsford Spring discharges from the Upper Member of the St. Louis Limestone (Fox, 1965) at about 114 m (375 ft) elevation. A second discharge point from this system occurs as a boil (Lawrence Boils) along the north bank of Little River about 275 m (900 ft) northeast of the main spring. The trend of the conduit feeding the boil may follow a steep, down-dip path, where the structure dips to the northeast about 15 m (50 ft) over the 275 m (900 ft) distance. A minor cave where the spring flow can be observed is located just northeast of the main spring (Dyas, 1979). Two higher-level short caves, which may have been the original outlets for the basin, are located about 90 m (300 ft) south of the main spring. A possible paleo-spring site may also exist about 180 m (600 ft) southwest of the spring. A 30 m (100 ft)-deep collapse sinkhole containing a 3-6 m wide perennial pool is located about 150 m (500 ft) east of the spring. This collapse sinkhole may be responsible for diverting the conduit flow into two separate discharge points, one of which is confined beneath the Little River.

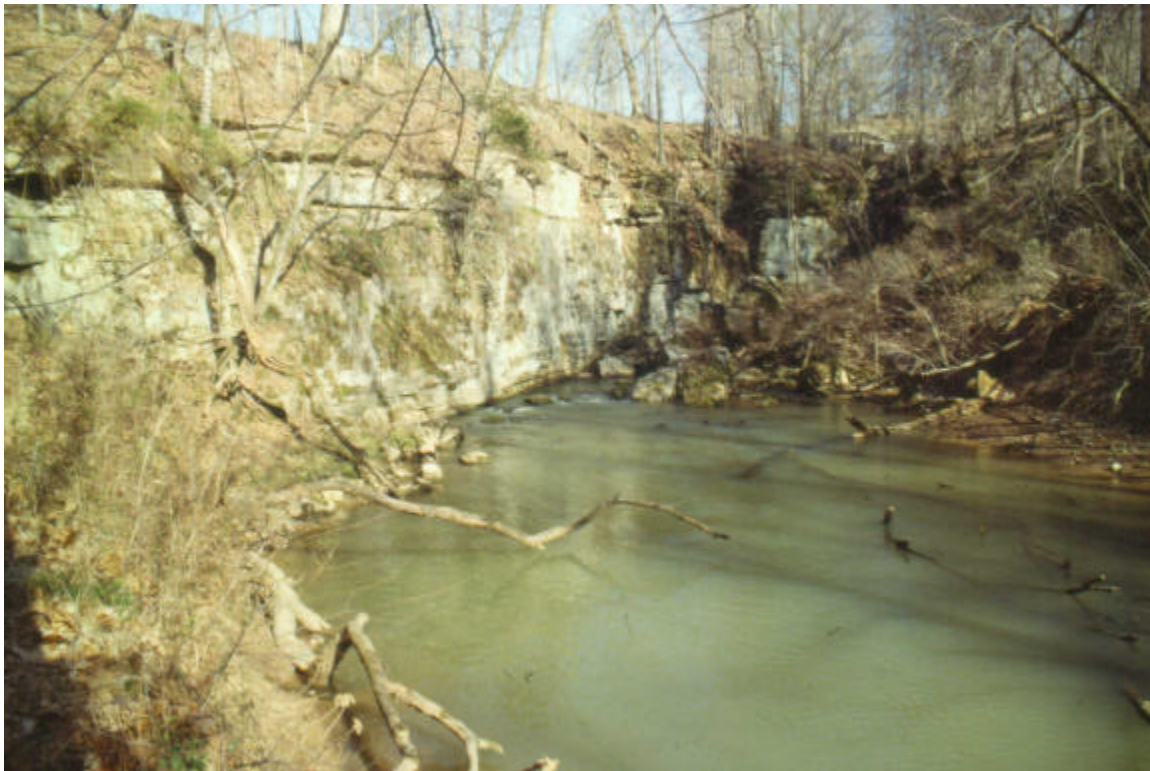
**Figure 13a: Mill Stream Spring**

**Mill Stream Spring** (Figures 13a and 13b), in east-central Trigg County [N36°-50'-38"; W87°-42'-49"], is a rising spring that flows from the base of an 8 m (25 ft)-high limestone bluff, through a 180 m (600 ft)-long pocket valley.

Mill Stream Spring discharges from the base of the Ste. Genevieve Limestone (Ulrich and Klemic, 1966) at about 119 m (390 ft) elevation. Ruins of an old water mill are located about 60 m (200 ft) from the springhead. Mill Stream Spring is one of four named springs on the Caledonia 7.5 minute Topographic Map.
